**Flood Control Project Maintenance
Levee Inspections**
LMA District Cover Sheet
Spring 2017 Levee Inspection Results

Reclamation District No. 0554 Walnut Grove

Spring 2017 Levee Inspection Results

Waterway			Bank	Unit Miles
Unit No. 01 Sacramento River			Left	1.13
	Spring (March - May)	Summer (June - August)	(September - November) Fall	Winter (December - February)
Unit Maintenance Rating (Fall Only)				
Date of Inspection	4/18/2017 - 4/18/2017			
DWR Inspector	Herman Phillips			
Accompanied By	Gilbert Labrie

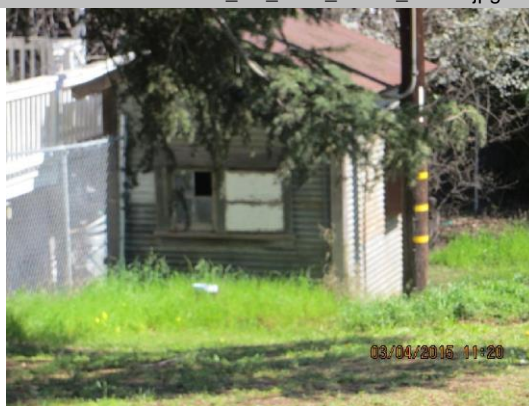
Photo 1 of 3 : UCIP_SP_2017_43726_73282.jpg

LM Start	0.02	Rating **	M	Issue No.	38
LM End	0.02	Issue Type +	En	Location *	WS
Category	Supplemental			GPS Latitude/Longitude	
				Start	End
Item	DWR UCIP Field Study			38.249553 °	38.249553 °
				-121.509954 °	-121.509954 °
DWR ID					
Comment Code					
Inspector Comment					
FS_ID:43726 DS_ID:18976 EP_NO: N/A Repair Type: Non-Urgent Crossing Status: Indicator Found UCIP Comments: Need to verify status of crossing with town of Locke. FIELD_STRUCT_DESC: Waterline of unknown diameter through the levee at unknown depth. Likely a 1 or 2-inch galvanized iron pipe. Crosses levee just south of concrete block pumphouse on WS shoulder and terminates at well house off LS toe. Gatevalve next to corner of pumphouse off LS toe. Drawings depicting approximate location available in PN: 12944. FS Date: 3/4/2015 4:49:00 PM

Pumphouse off LS toe.

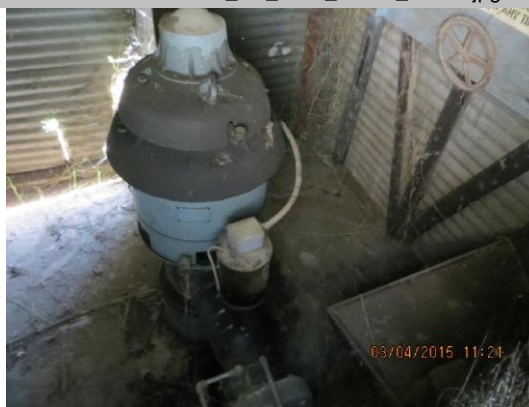
Photo 2 of 3 : UCIP_SP_2017_43726_73281.jpg

Pump over well inside pumphouse on LS toe.

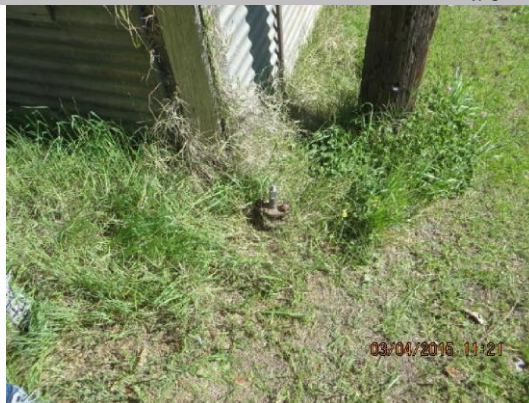
Photo 3 of 3 : UCIP_SP_2017_43726_73280.jpg

Gatevalve at corner of pumphouse on LS toe.

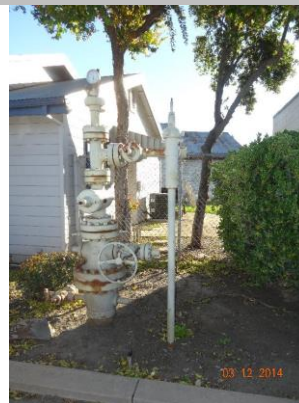
Photo 1 of 1 : UCIP_SP_2017_42146_58463.jpg

LM Start	0.08	Rating **	U	Issue No.	40
LM End	0.08	Issue Type +	En	Location *	WS
Category	Supplemental			GPS Latitude/Longitude	
				Start	End
Item	DWR UCIP Field Study			38.248643 °	38.248643 °
				-121.509850 °	-121.509850 °
DWR ID					
Comment Code					
Inspector Comment					
FS_ID:42146					
DS_ID:20946					
EP_NO: 5607					
Repair Type: Urgent					
Crossing Status: Indicator Found					
UCIP Comments: No markers. Valves abandoned on landward side--need to contact owner to determine status of crossing.					
FIELD_STRUCT_DESC: Abandoned three 4-inch steel petroleum pipes through the levee, 22.5 feet below the crown. Pipes placed in 8-inch pipe casing through the levee and plugged with concrete. Abandoned under Permit No. 5607 (1966).					
FS Date: 3/12/2014

Valves located on landward side.

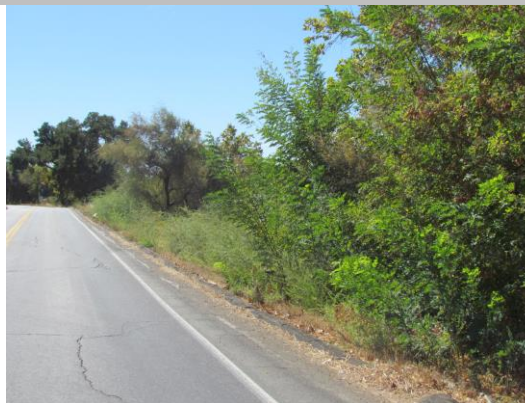
Photo 1 of 1 : SP_2017_RD0554_176_31_20170404_00007.jpg

LM Start	0.08	Rating **	U	Issue No.	31
LM End	0.36	Issue Type +	Ma	Location *	WS
Category	Earthen Levee			GPS Latitude/Longitude	
				Start	End
Item	Vegetation			38.248638 °	38.244872 °
				-121.509872 °	-121.511600 °
DWR ID	DWR_RD0554_01_f_2016_31				
Comment Code					
V2 : Remove the wild growth other than native grasses from the levee slopes.					
Inspector Comment					
Remove the wild growth from the levee slope along the waterside levee section.

Looking downstream waterside levee slope from levee mile 0.08-0.30.

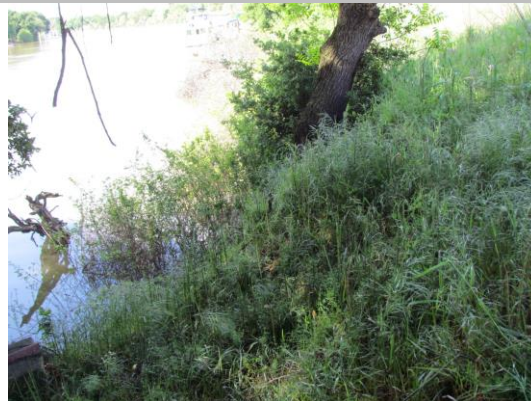
Photo 1 of 1 : SP_2017_RD0554_176_11_20170509_00057.jpg

LM Start	0.10	Rating **	U	Issue No.	11
LM End	0.10	Issue Type +	Ma	Location *	WS
Category	Earthen Levee			GPS Latitude/Longitude	
				Start	End
Item	Erosion / Bank Caving			38.248262 °	38.248262 °
				-121.509901 °	-121.509901 °
DWR ID	DWR_RD0554_01_s_2014_11				
Comment Code					
E1 : Note and monitor erosion site.					
Inspector Comment					
This is not a new erosion site, repairs are needed. One tree has fallen into the Sac River at the erosion site. This site can be seen better from the river by boat. The wild grapes blocks the view from the waterside shoulder looking down the slope.

RD 554 Waterside levee slope erosion into the bank, the wild vegetation growth blocks the view.

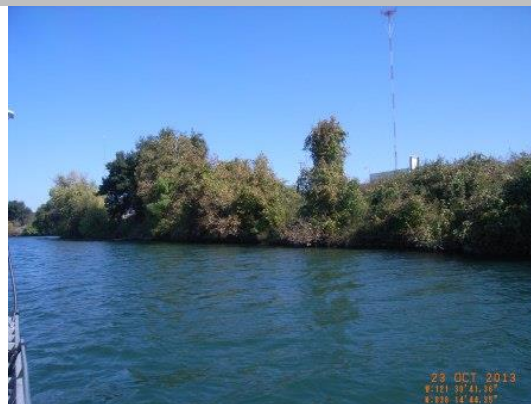
Photo 1 of 2 : SP_2017_RD0554_176_1_20170404_00001.jpg

LM Start	0.26	Rating **	M	Issue No.	1
LM End	0.36	Issue Type +	Ma	Location *	WS
Category	Supplemental			GPS Latitude/Longitude	
				Start	End
Item	2015 USACE Erosion Survey, DRAFT			38.246222 °	38.245017 °
				-121.510878 °	-121.511740 °
DWR ID	DWR_RD0554_01_f_2016_1				
Comment Code					
Inspector Comment					
2009 - Tension cracks on road on top of levee. Erosion into the levee slope and mass failure. 2013 - Short vertical sections at bank toe. 2015: No observed changes. [2015 Site ID: SAC_27-0_L]

USACE 2013 Photo #1

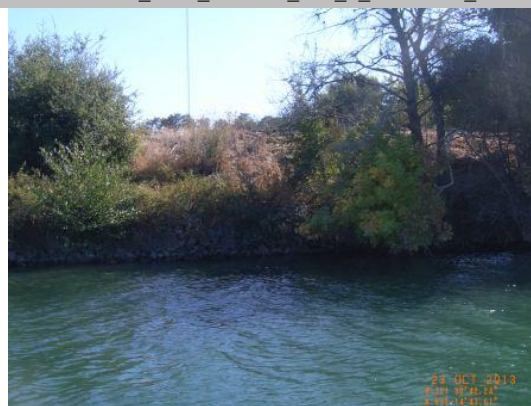
Photo 2 of 2 : SP_2017_RD0554_176_1_20170404_00002.jpg

USACE 2013 Photo #2

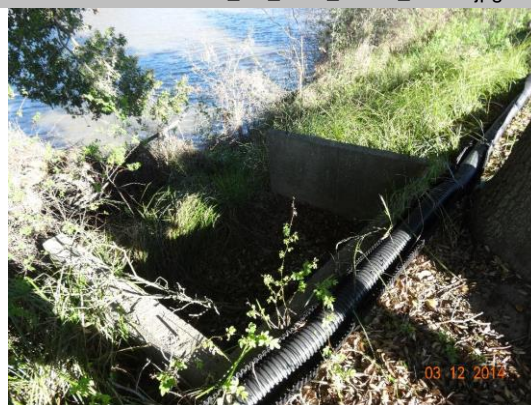
Photo 1 of 3 : UCIP_SP_2017_32018_58469.jpg

LM Start	0.27	Rating **	M	Issue No.	41
LM End	0.27	Issue Type +	En	Location *	WS
Category	Supplemental			GPS Latitude/Longitude	
				Start	End
Item	DWR UCIP Field Study			38.246093 °	38.246093 °
				-121.510731 °	-121.510731 °
DWR ID					
Comment Code					
Inspector Comment					
FS_ID:32018					
DS_ID:20897					
EP_NO: N/A					
Repair Type: Non-Urgent					
Crossing Status: Indicator Found					
UCIP Comments: Unable to determine status of crossing--was crossing removed during erosion repair site in 2007-2009? Need to coordinate with LMA or owner to obtain additional information about crossing.					
FIELD_STRUCT_DESC: *ABANDONED* 6-inch pipe through the levee, 1.0-foot below the crown. Concrete pump pad on the waterward slope.					
O+M manual entry at RM 27.00, 1959.					
FS Date: 3/12/2014

Concrete U wall located on waterward side.

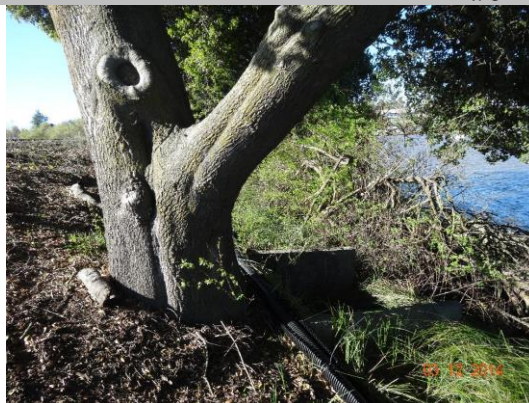
Photo 2 of 3 : UCIP_SP_2017_32018_58468.jpg

Concrete vault located on waterward side. Site is a erosion repair site.

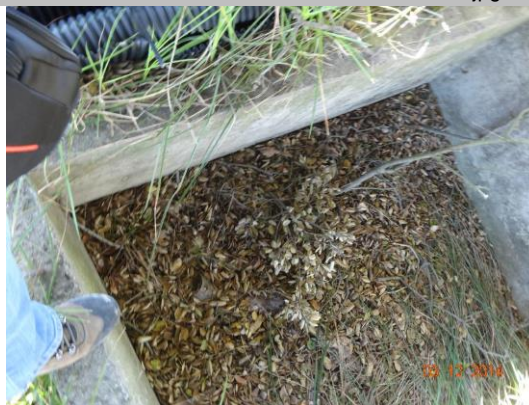
Photo 3 of 3 : UCIP_SP_2017_32018_58467.jpg

Concrete face no outlet visible on waterward side.

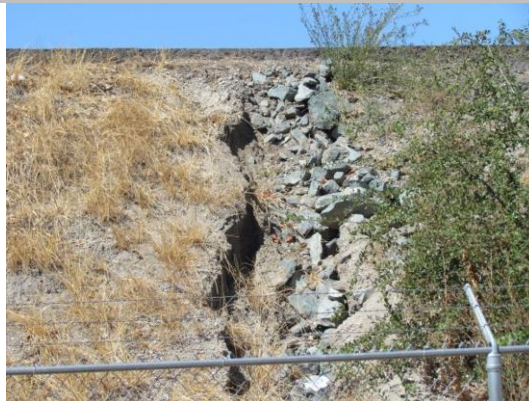
Photo 1 of 2 : SP_2017_RD0554_176_13_20170404_00004.jpg

LM Start	0.32	Rating **	U	Issue No.	13
LM End	0.32	Issue Type +	Ma	Location *	LS
Category	Earthen Levee			GPS Latitude/Longitude	
				Start	End
Item	Erosion / Bank Caving			38.245389 °	38.245389 °
				-121.511085 °	-121.511085 °
DWR ID	DWR_RD0554_01_s_2014_13				
Comment Code					
E2 : Schedule repair of erosion site prior to the next inspection.					
Inspector Comment					
This erosion isn't repaired to date. Needs repairing.

This erosion along the landside levee slope is not new, it was reported two years ago.

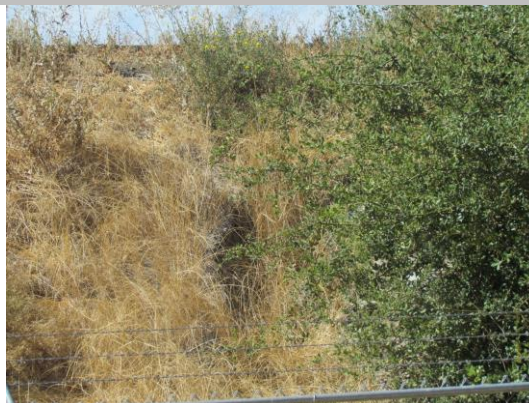
Photo 2 of 2 : SP_2017_RD0554_176_13_20170404_00005.jpg

This erosion site along the landside slope levee 0.32 has been reported and has not been repaired.

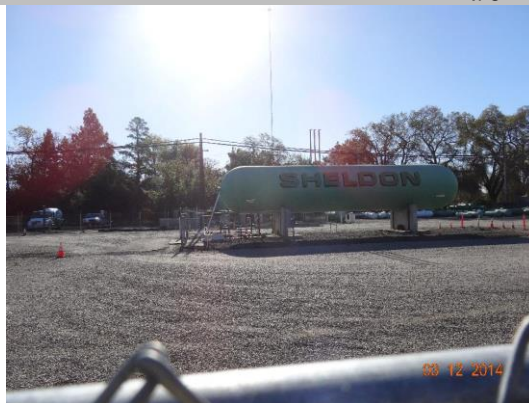
Photo 1 of 1 : UCIP_SP_2017_42143_60800.jpg

LM Start	0.33	Rating **	U	Issue No.	42
LM End	0.33	Issue Type +	En	Location *	LS
Category	Supplemental			GPS Latitude/Longitude	
				Start	End
Item	DWR UCIP Field Study			38.245295 °	38.245295 °
				-121.511274 °	-121.511274 °
DWR ID					
Comment Code					
Inspector Comment					
FS_ID:42143 DS_ID:20922 EP_NO: N/A Repair Type: Urgent Crossing Status: Indicator Found UCIP Comments: No markers found. Need to contact owner to determine status of crossing. Unable to confirm if crossings are still active or if they cross levee. FIELD_STRUCT_DESC: 1 of 3: 3-inch steel fuel line through the levee, 2.7 feet below the crown. (USACE-1959). This entry matches the Drainage or Irrigation Structure referenced in O&M manual (RM 27.20). FS Date: 3/12/2014

Tank found on landward side.

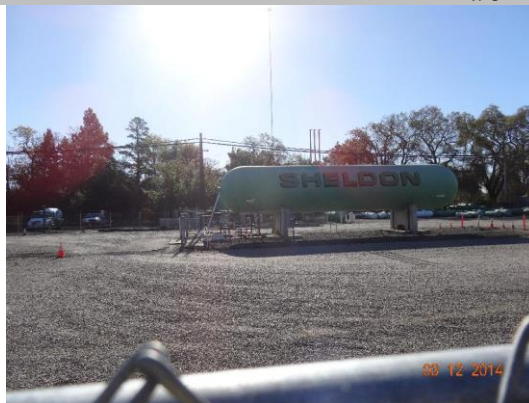
Photo 1 of 1 : UCIP_SP_2017_42144_60801.jpg

LM Start	0.33	Rating **	U	Issue No.	43
LM End	0.33	Issue Type +	En	Location *	LS
Category	Supplemental			GPS Latitude/Longitude	
				Start	End
Item	DWR UCIP Field Study			38.245295 °	38.245295 °
				-121.511274 °	-121.511274 °
DWR ID					
Comment Code					
Inspector Comment					
FS_ID:42144 DS_ID:20932 EP_NO: N/A Repair Type: Urgent Crossing Status: Indicator Found UCIP Comments: No markers found. Need to contact owner to determine status of crossing. Unable to confirm if crossings are still active or if they cross levee. FIELD_STRUCT_DESC: 2 of 3: 3-inch steel fuel line through the levee, 2.7 feet below the crown. (USACE-1959). This entry matches the Drainage or Irrigation Structure referenced in O&M manual (RM 27.20). FS Date: 3/12/2014

Fuel tank located on landward side.

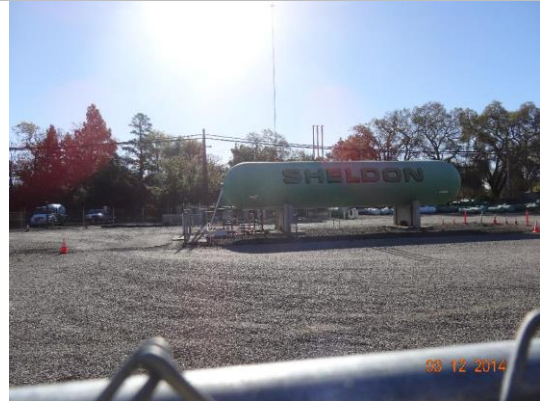
Photo 1 of 1 : UCIP_SP_2017_42145_60802.jpg

LM Start	0.33	Rating **	U	Issue No.	44
LM End	0.33	Issue Type +	En	Location *	LS
Category	Supplemental			GPS Latitude/Longitude	
				Start	End
Item	DWR UCIP Field Study			38.245295 °	38.245295 °
				-121.511274 °	-121.511274 °
DWR ID					
Comment Code					
Inspector Comment					
FS_ID:42145					
DS_ID:20933					
EP_NO: N/A					
Repair Type: Urgent					
Crossing Status: Indicator Found					
UCIP Comments: No markers. Need to contact owner to determine status of crossing. Unable to confirm if crossings are still active or if they cross levee.					
FIELD_STRUCT_DESC: 3 of 3: 3-inch steel fuel line through the levee, 2.7 feet below the crown. (USACE-1959). This entry matches the Drainage or Irrigation Structure referenced in O&M manual (RM 27.20).					
FS Date: 3/12/2014

Fuel tank located on landward side.

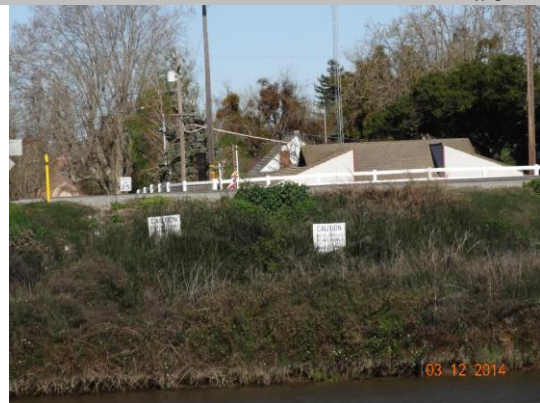
Photo 1 of 3 : UCIP_SP_2017_43694_58063.jpg

Comment Code					
Inspector Comment					
FS_ID:43694					
DS_ID:20899					
EP_NO: 5429					
Repair Type: Non-Urgent					
Crossing Status: Indicator Found					
UCIP Comments: Signs of open cut along crossing--no markers visible on waterward or landward side. Large across channel on right bank berm indicating cable through levee.					
FIELD_STRUCT_DESC: Four 4-inch iron conduits through the levee, at various depths below the crown (3.0-4.9 feet). Each conduit encases a shielded telephone cable. Concrete cutoff wall around pipes on landward levee shoulder. Riser pole off the landward levee toe. (Permit No. 5429-1967) Replacement telephone conduits were pulled through iron conduits under Permit No. 13417 (1983).					
FS Date: 3/4/2015

Signs for conduits visible on right bank across channel. Conduits cross left bank, channel, and right bank.

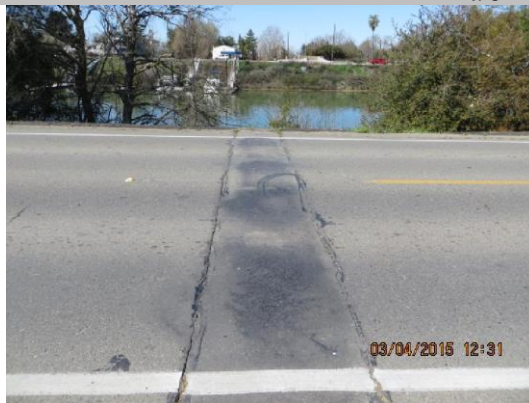
Photo 2 of 3 : UCIP_SP_2017_43694_73221.jpg

View of waterside from landside shoulder. Cuts in pavement indicate presence of pipe trench across levee.

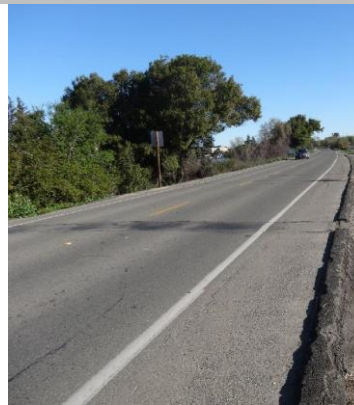
Photo 3 of 3 : UCIP_SP_2017_43694_58062.jpg

Signs of cut through levee at conduit.

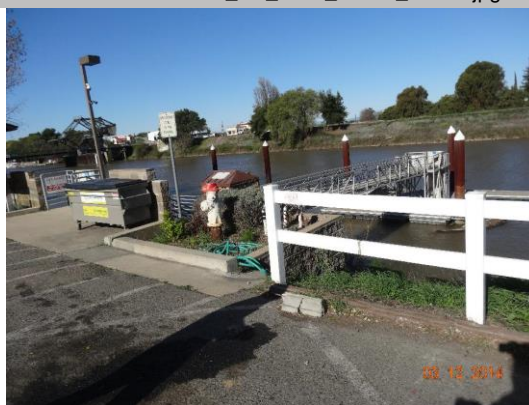
Photo 1 of 3 : UCIP_SP_2017_43734_58085.jpg

Comment Code					
Inspector Comment					
FS_ID:43734 DS_ID:20901 EP_NO: 11155 Repair Type: Non-Urgent Crossing Status: Indicator Found UCIP Comments: Multiple crossings at same location--unable to confirm if crossing matches details under permit 11155. Need to contact owner to obtain additional information about crossing status. FIELD_STRUCT_DESC: 1 of 3: 6-inch pipe through the levee, 5.5 feet below the crown. Pipe retained under ABO No. 11155 (1975). Pipe originally included in O+M manual, 1959, at RM 26.75. Fire hydrant on WS shoulder and valve in cut visible in roadway. Electrical utility box on LS shoulder. Electrical lines visible on WS at ramp. FS Date: 3/12/2014

Multiple lines through levee crown visible on waterward shoulder.

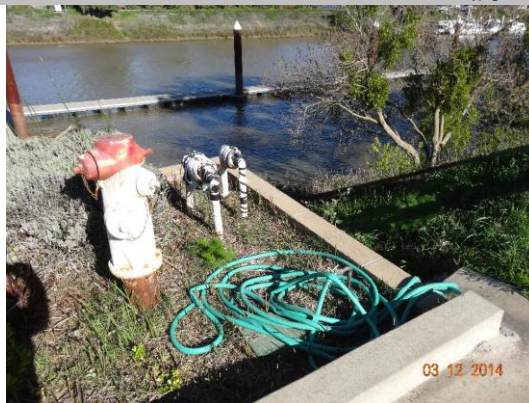
Photo 2 of 3 : UCIP_SP_2017_43734_58083.jpg

Lines visible on waterward side.

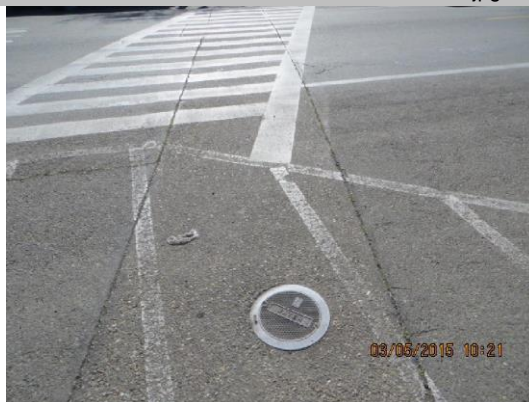
Photo 3 of 3 : UCIP_SP_2017_43734_73227.jpg

Cuts in pavement and lid for water valve visible from WS shoulder.

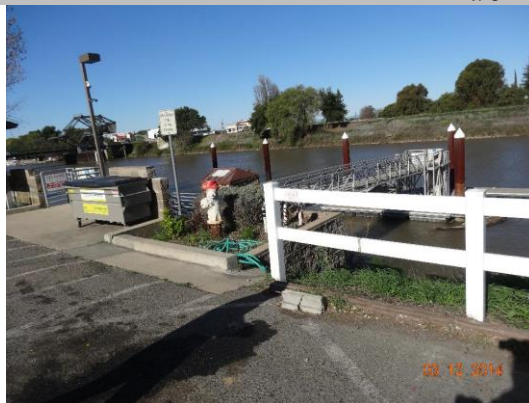
Photo 1 of 3 : UCIP_SP_2017_43735_58097.jpg

Comment Code					
Inspector Comment					
FS_ID:43735 DS_ID:20937 EP_NO: 11155 Repair Type: Non-Urgent Crossing Status: Indicator Found UCIP Comments: Multiple crossings at same location--unable to confirm if crossing matches details under permit 11155. Need to contact owner to obtain additional information about crossing status. FIELD_STRUCT_DESC: 2 of 3: 6-inch pipe through the levee, 5.5 feet below the crown. Pipe retained under ABO No. 11155 (1975).Pipe originally included in O+M manual, 1959, at RM 26.75. Fire hydrant on WS shoulder and valve in cut visible in roadway. Electrical utility box on LS shoulder. Electrical lines visible on WS at ramp. FS Date: 3/5/2015

Multiple crossing visible on waterward shoulder.

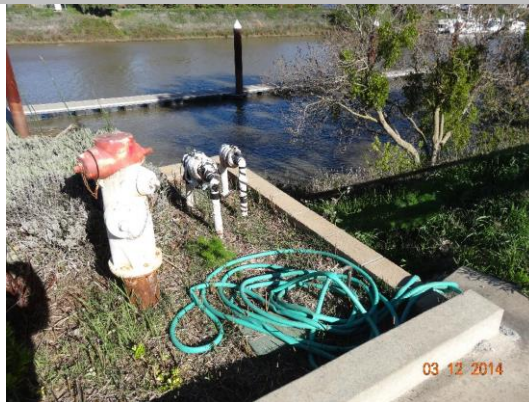
Photo 2 of 3 : UCIP_SP_2017_43735_58095.jpg

Crossings visible on waterward side.

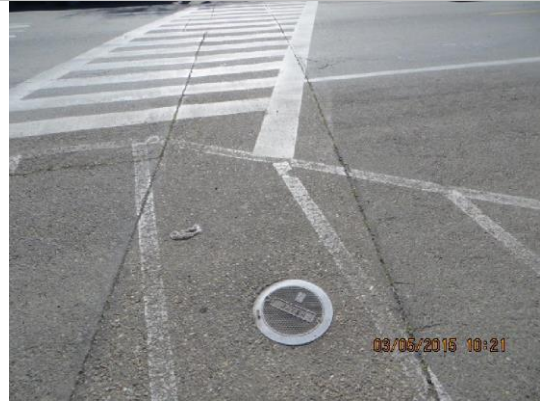
Photo 3 of 3 : UCIP_SP_2017_43735_73255.jpg

Cuts in pavement visible from WS shoulder. Valve visible in roadway.

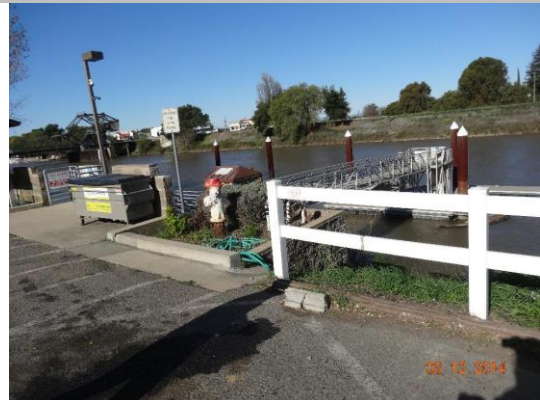
Photo 1 of 3 : UCIP_SP_2017_43736_58091.jpg

Comment Code					
Inspector Comment					
FS_ID:43736 DS_ID:20938 EP_NO: 11155 Repair Type: Non-Urgent Crossing Status: Indicator Found UCIP Comments: Multiple crossings at same location--unable to confirm if crossing matches details under permit 11155. Need to contact owner to obtain additional information about crossing status. FIELD_STRUCT_DESC: 3 of 3: 6-inch pipe through the levee, 10.5 feet below the crown. Pipe retained under ABO No. 11155 (1975).Pipe originally included in O+M manual, 1959, at RM 26.75. Fire hydrant on WS shoulder and valve in cut visible in roadway. Electrical utility box on LS shoulder. Electrical lines visible on WS at ramp. FS Date: 3/5/2015

View of multiple crossings through levee.

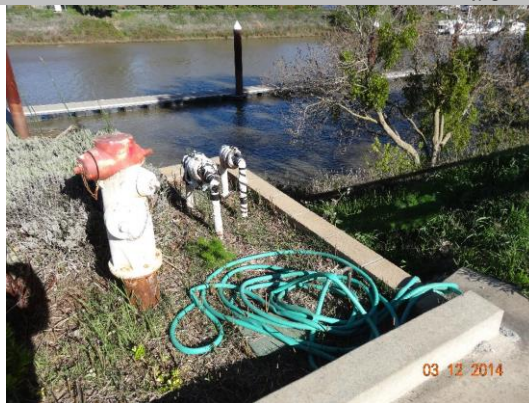
Photo 2 of 3 : UCIP_SP_2017_43736_58089.jpg

Crossings visible on waterward shoulder.

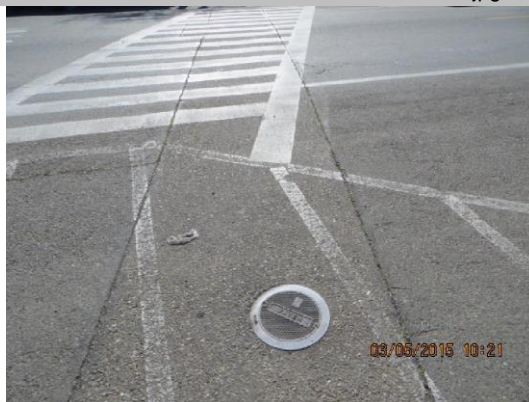
Photo 3 of 3 : UCIP_SP_2017_43736_73259.jpg

Cuts in pavement visible from WS shoulder. Valve visible in roadway.

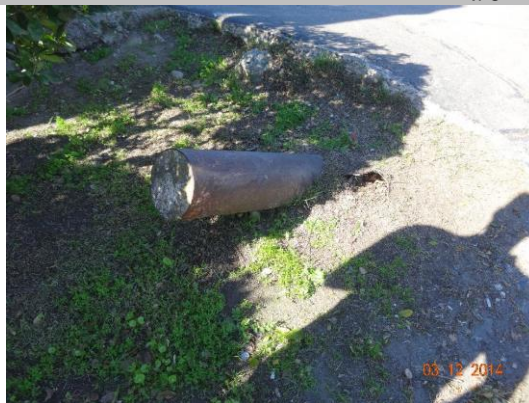
Photo 1 of 1 : UCIP_SP_2017_32020_58473.jpg

LM Start	0.60	Rating **	M	Issue No.	49
LM End	0.60	Issue Type +	En	Location *	WS
Category	Supplemental			GPS Latitude/Longitude	
				Start	End
Item	DWR UCIP Field Study			38.242101 °	38.242101 °
				-121.514086 °	-121.514086 °
DWR ID					
Comment Code					
Inspector Comment					
FS_ID:32020					
DS_ID:20912					
EP_NO: 11154					
Repair Type: Non-Urgent					
Crossing Status: Indicator Found					
UCIP Comments: Unable to confirm if this pipe section is the same one listed under 11154. Need to contact owner to determine status and obtain additional information about crossing.					
FIELD_STRUCT_DESC: *ABANDONED* 8-inch pipe through the levee, 9.8 feet below the crown. Pump on LS toe. Included in O+M manual at RM 26.66. Pipe retained under ABO No. 11154 (1975).					
FS Date: 3/12/2014

Steel pipe filled with concrete visible on landward shoulder.

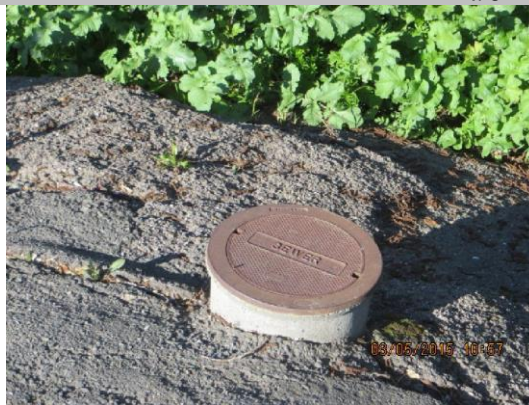
Photo 1 of 3 : UCIP_SP_2017_43805_73320.jpg

LM Start	0.64	Rating **	M	Issue No.	50
LM End	0.64	Issue Type +	En	Location *	WS
Category	Supplemental			GPS Latitude/Longitude	
				Start	End
Item	DWR UCIP Field Study			38.241550 °	38.241550 °
				-121.514535 °	-121.514535 °
DWR ID					
Comment Code					
Inspector Comment					
FS_ID:43805 DS_ID:25080 EP_NO: N/A Repair Type: Non-Urgent Crossing Status: Found UCIP Comments: No permit found. Further investigation required. FIELD_STRUCT_DESC: 4-inch Cast iron Sewer pipe through the levee at an unknown depth. Pipe visible on bridge. Sewer cleanout on WS shoulder and cut in pavement visible in roadway. (Permit No. 870, 1941) FS Date: 3/5/2015

Sewer cleanout on WS shoulder.

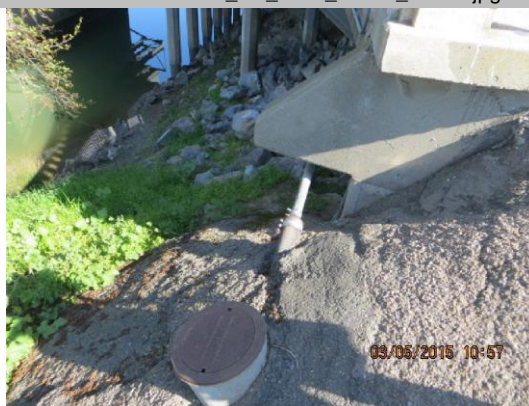
Photo 2 of 3 : UCIP_SP_2017_43805_73321.jpg

Pipe visible at bridge on WS shoulder.

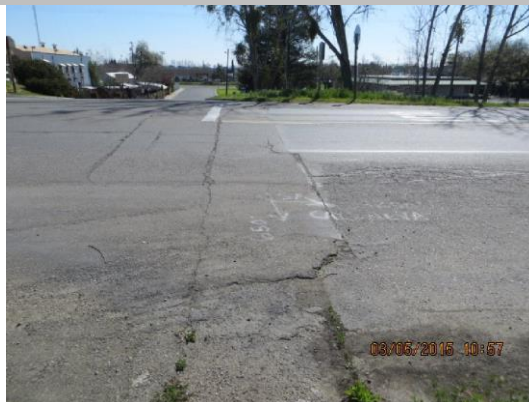
Photo 3 of 3 : UCIP_SP_2017_43805_73322.jpg

Cut in pavement at pipe alignment.

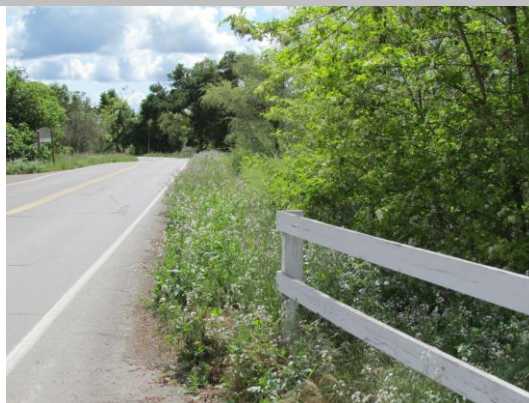
Photo 1 of 1 : SP_2017_RD0554_176_33_20170509_00058.jpg

Looking downstream from levee mile 0.77 wild vegetation on the waterward slope and shoulder within the Veg. Site.

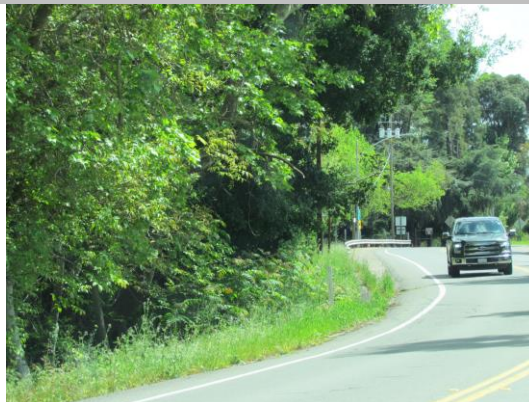
Photo 1 of 1 : SP_2017_RD0554_176_30_20170509_00059.jpg

Looking downstream at the wild growth on the landside levee slope.

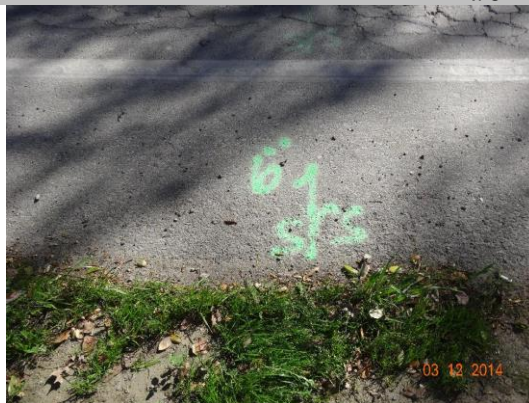
Photo 1 of 3 : UCIP_SP_2017_32021_58475.jpg

LM Start	0.89	Rating **	M	Issue No.	51
LM End	0.89	Issue Type +	En	Location *	LS
Category	Supplemental			GPS Latitude/Longitude	
				Start	End
Item	DWR UCIP Field Study			38.238595 °	38.238595 °
				-121.516945 °	-121.516945 °
DWR ID					
Comment Code					
Inspector Comment					
FS_ID:32021 DS_ID:20941 EP_NO: N/A Repair Type: Non-Urgent Crossing Status: Indicator Found UCIP Comments: Unable to confirm how many sewer lines cross levee. Desk study shows 2 crossings 4-inch not 6 inch. Need to contact owner to confirm status of crossing. FIELD_STRUCT_DESC: 1 of 2: 4-inch clay sewer pipe through the levee, 10.2 feet below the crown. (USACE-1959). This entry matches the Drainage or Irrigation Structure referenced in O&M manual (RM 26.50). FS Date: 3/12/2014 2:06:00 PM

Underground service alert (USA) markers confirming sewer line.

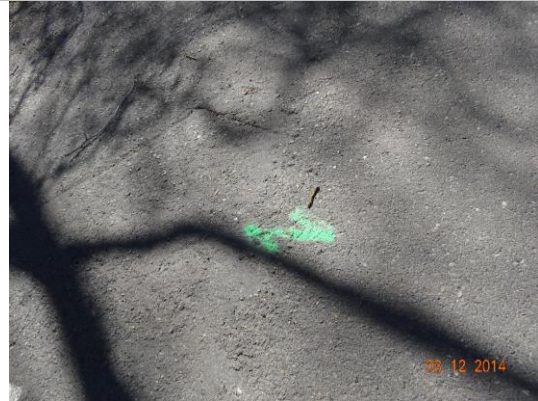
Photo 3 of 3 : UCIP_SP_2017_32021_58477.jpg

View of USA marker on waterward side.

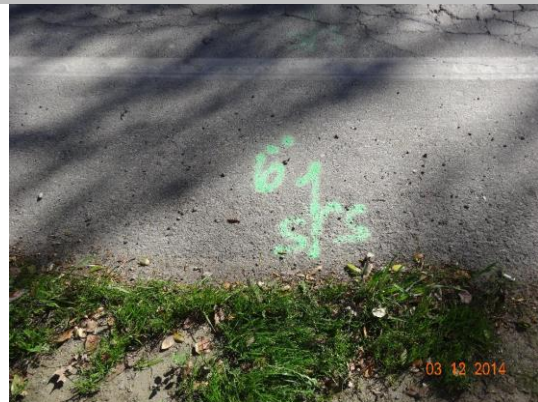
Photo 1 of 3 : UCIP_SP_2017_32022_58480.jpg

Underground service alert (USA) marker on waterward shoulder for sewer line.

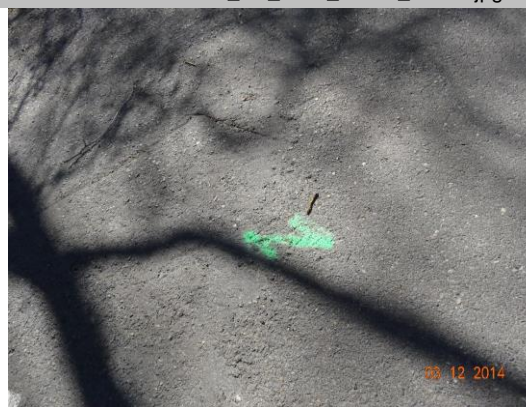
Photo 3 of 3 : UCIP_SP_2017_32022_58478.jpg

View of landward shoulder--USA marker.

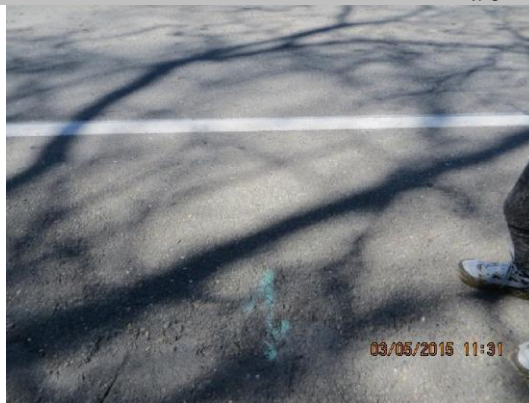
Photo 1 of 3 : UCIP_SP_2017_43804_73323.jpg

USAA SS marking on LS shoulder.

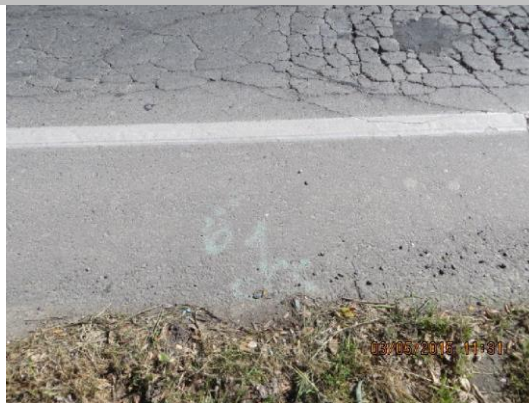
Photo 2 of 3 : UCIP_SP_2017_43804_73324.jpg

USAA SS marking on LS shoulder.

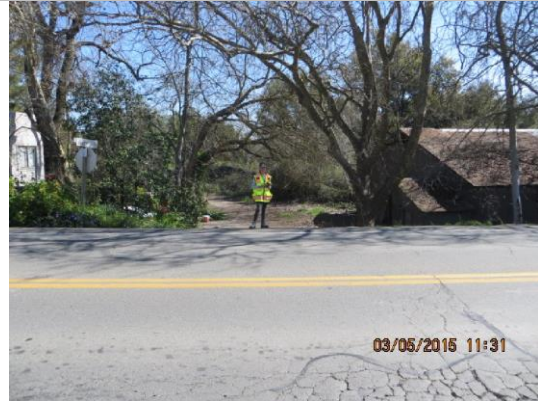
Photo 3 of 3 : UCIP_SP_2017_43804_73325.jpg

Alignment through center of driver on LS shoulder.

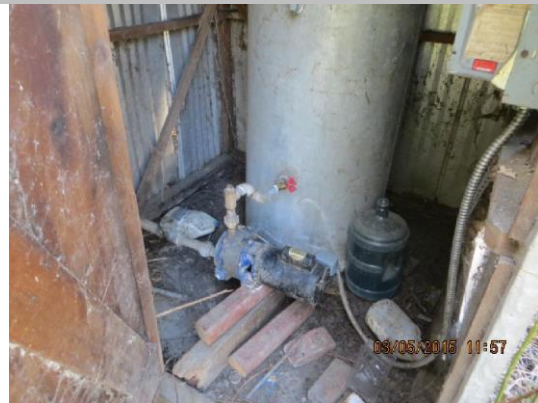
Photo 1 of 3 : UCIP_SP_2017_50027_73243.jpg

Pressurized tank, meter and pump in pumphouse on LS toe.

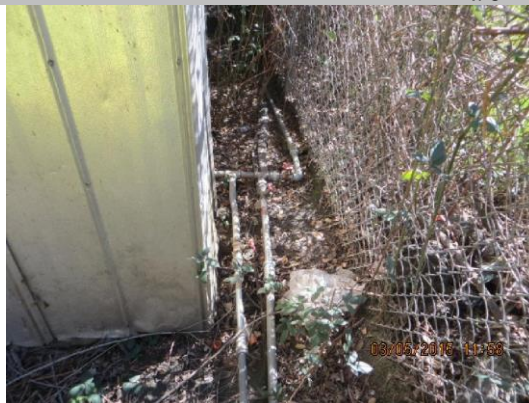
Photo 2 of 3 : UCIP_SP_2017_50027_73244.jpg

A 1-inch and a 1.5-inch galvanized iron drinking water pipe with shutoff valves at pumphouse on LS toe.

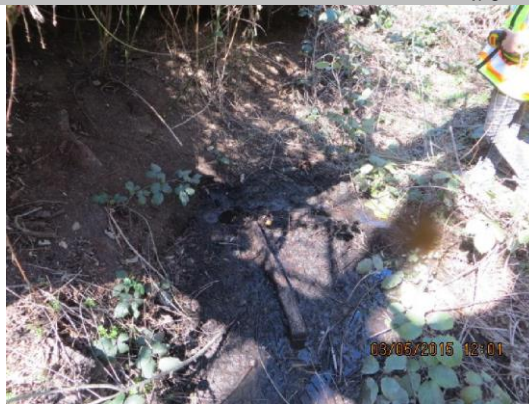
Photo 3 of 3 : UCIP_SP_2017_50027_73246.jpg

Pipe leak at LS toe 23 ft upstream from pumphouse.

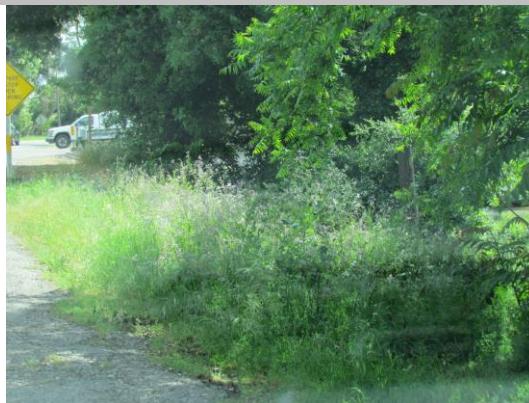
Photo 1 of 1 : SP_2017_RD0554_176_37_20170509_00055.jpg

Looking downstream from levee mile 0.93 waterside slope blocking the view of the levee slope.

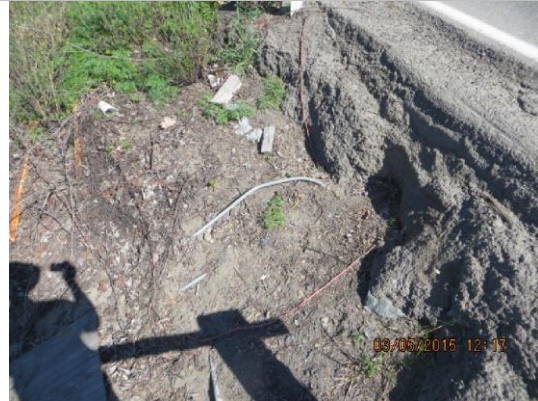
Photo 3 of 3 : UCIP_SP_2017_43810_73330.jpg

Possible outlet on WS shoulder.

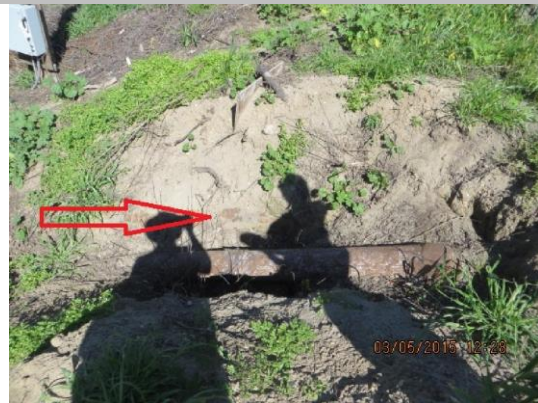
Photo 1 of 1 : UCIP_SP_2017_43747_73286.jpg

Abandoned pipe was exposed on WS slope when a trench was opened to repair the other 8-inch pipe at the site.

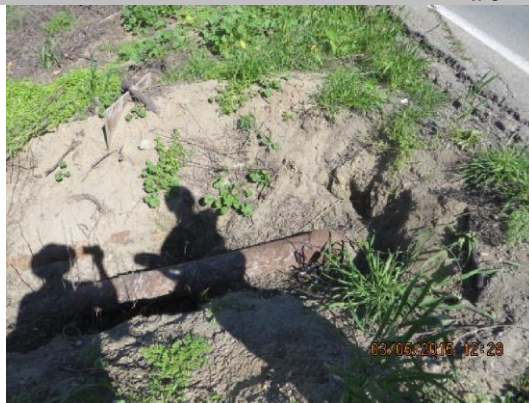
Photo 1 of 3 : UCIP_SP_2017_43748_73289.jpg

Pipe in open trench on WS slope. Repair patch on pipe.

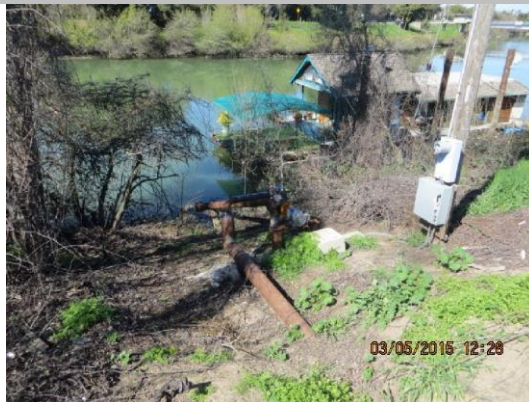
Photo 2 of 3 : UCIP_SP_2017_43748_73288.jpg

Pipe exposed on WS slope. pump, shutoff valve, and meter on pole on WS slope.

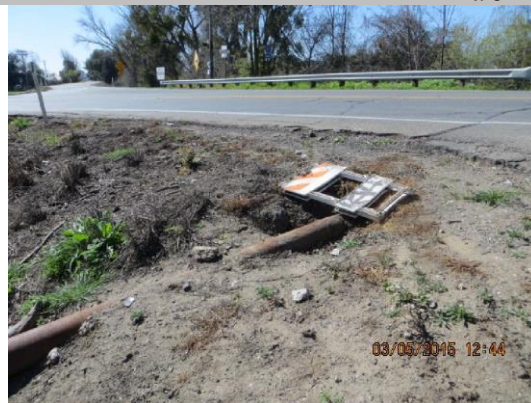
Photo 3 of 3 : UCIP_SP_2017_43748_73287.jpg

Pipe exposed on LS shoulder.
